Manhole Inspection Summary

Manhole # S43AA_013MH

Insp Date: **6/30/08 9:59 AM**

Location Address: **Monument**

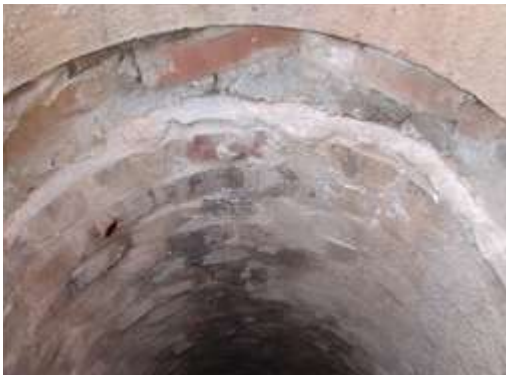
Defect 2

Condition: ☐ Sound ☐ Cracked ☐ Root Intrusion ☒ **Loose Brick** ☐ Deteriorated

Infiltration: ☐ None ☐ Joint ☐ Cracks ☒ **Mortar** ☐ Roots ☒ **Wall**

loose bricks

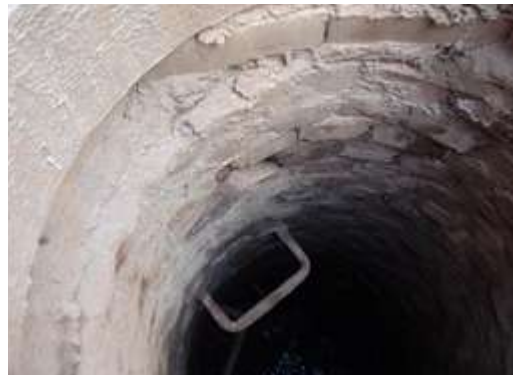
Defect 1

frame leaks

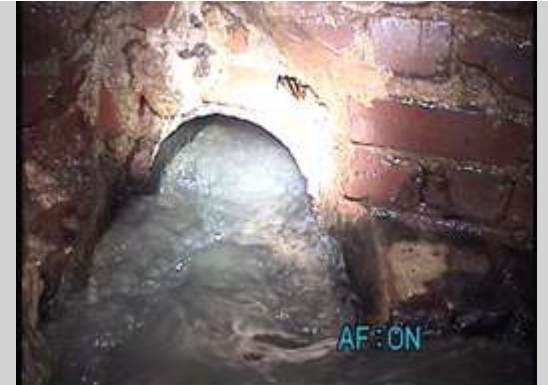
12 O'Clock Outflow

10 in. Circular Gravity Sewer
Pipe Out @ 12 O'Clock

Pipe Height: **10.8** (in.) Rod and Bar (Angled)
Pipe Material: **Clay** ☐ Pipe Lined
Invert Depth: **16.10** (ft.) Flow Characteristics: **Fast**
Deposits: ☒ None ☐ Mud ☐ Sludge ☐ Debris ☐ Grease
Silt Depth: (in.) Deposits Extent:
Infiltration: **None** Pipe Seal Cond: **Sound**

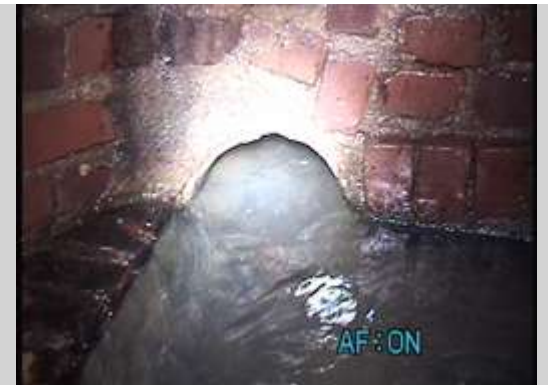
3 O'Clock Inflow

10 in. Circular Gravity Sewer
Pipe In @ 3 O'Clock

Pipe Height: **10.8** (in.) Rod and Bar (Angled)
Pipe Material: **Clay** ☐ Pipe Lined
Invert Depth: **16.20** (ft.) Flow Characteristics: **Fast**
Deposits: ☒ None ☐ Mud ☐ Sludge ☐ Debris ☐ Grease
Silt Depth: (in.) Deposits Extent:
Infiltration: **None** Pipe Seal Cond: **Sound**

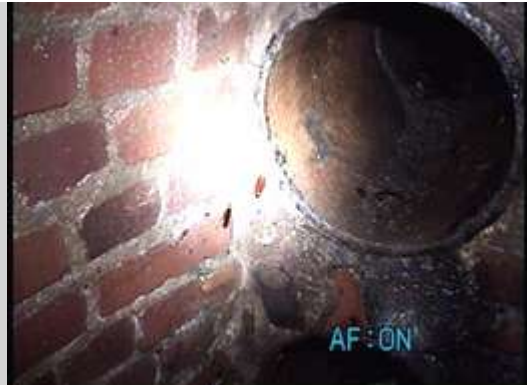
6 O'Clock Inflow

Pipe In @ 6 O'Clock

Infiltration: **None** Pipe Seal Cond: **Sound**

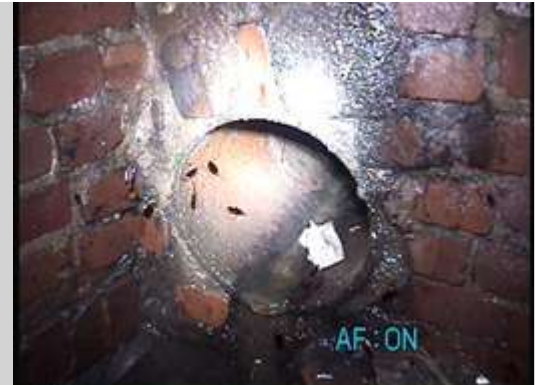
Drop In @ 6 O'Clock

Drop: **Inside**

Drop Condition: **Open**
